**LETTER REPORT  
FOR  
MOSCHIANO PLATING FACILITY SITE  
CHICAGO, COOK COUNTY, ILLINOIS  
TDD: S05-9708-003  
PAN: 7G0301RZXX**

**September 30, 1997**

Re: Moschiano Plating Facility Site  
Chicago, Cook County, Illinois  
TDD: S05-9708-003  
PAN: 7G0301RZXX

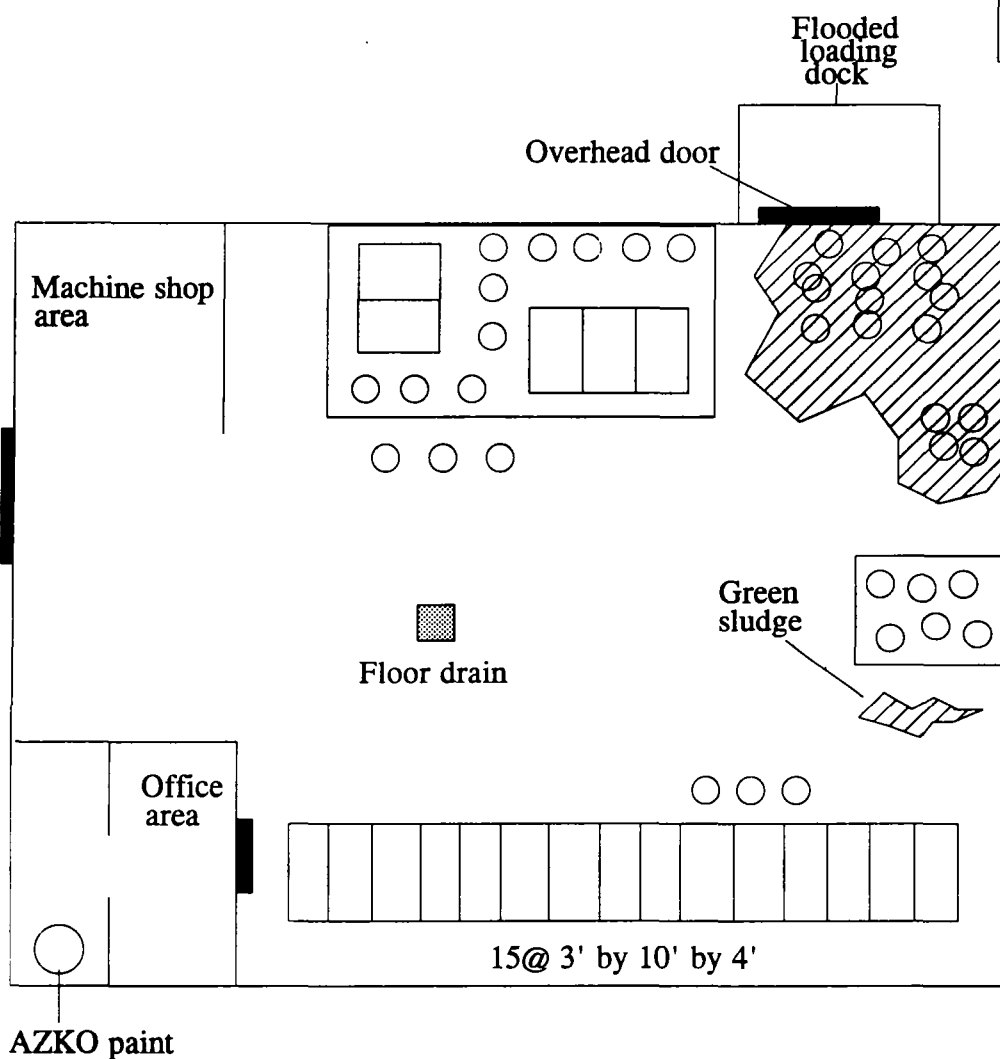
**Figure 2**  
**Building Layout Map**

At 1510 hours, START began a preliminary site assessment and began photodocumenting the site. It was immediately noticed that the roof of the building had partially collapsed and that several of the windows were broken. The roof cave-in was later found to have caused the release. In response to the potential hazard, MWRD Yarnik had ordered that the front door to the facility be padlocked shut. The rear dock and the main floor of the facility were flooded as a result of a broken water main inside the facility. It is believed that the main was broken during the roof collapse. Also, CDOE Schussler arranged to have the windows and the front entrance to the facility boarded shut. Flooding of the loading dock was observed outside the building. The water from the flooded loading dock was tested and to be of neutral pH (pH reading of 7 standard units). None of the plating lines appeared to be broken during the initial survey/reconnaissance.

At 1915 hours, Arrow Board-up Company, the contractor hired by CDOE, arrived on site to secure the building. Plywood, in conjunction with 2 x 4 boards, were used to cover the windows and doors to prevent unauthorized access. START Skare and CDOE Schussler departed the site after the building was secured.
